Thermal Test Report

Model Name: **RM11602**

Report No.: **E2009010905**
Revision 1.0
Date: **2009/01/15**

CHENBRO MICOM CO., LTD.

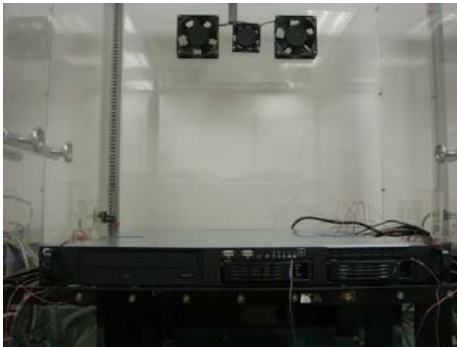
Fig. 1 – Thermal Chamber

The thermal chamber's picture is as following. This thermal chamber can control the Room Ambient Temperature (T-Room) at 35 degree C.
