Thermal Test Report

Model Name: **RM42300**

Report No.: **E2009043054**
Revision 1.0
Date: **2009/05/11**

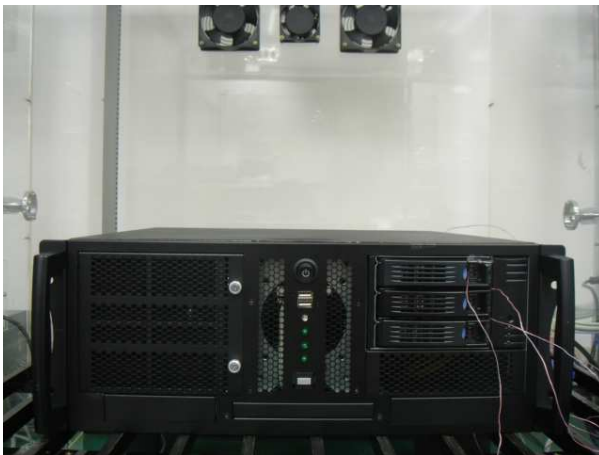
The thermal chamber's picture is as following. This thermal chamber can control the Room Ambient Temperature (T-Room) at 35 degree C.

Fig. 1 – Thermal Chamber

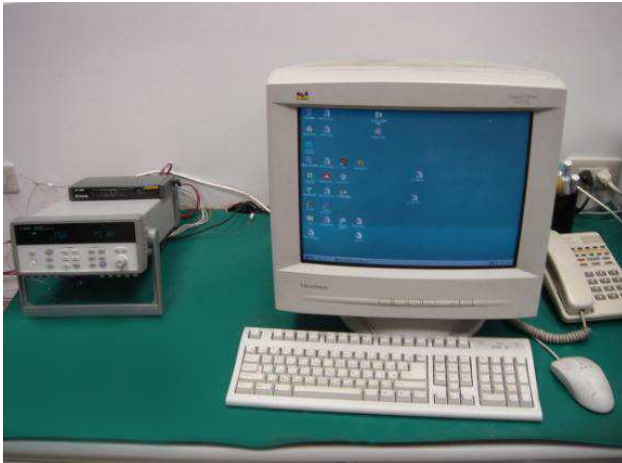
The picture of Data Acquisition System is as following. The Data Acquisition System includes one Agilent 34970A, 48 channel temperature recorder and one PC for logging the measured temperature data. The communication interface between recorder and PC is RS-232C.

Fig. 2 – Data Acquisition System

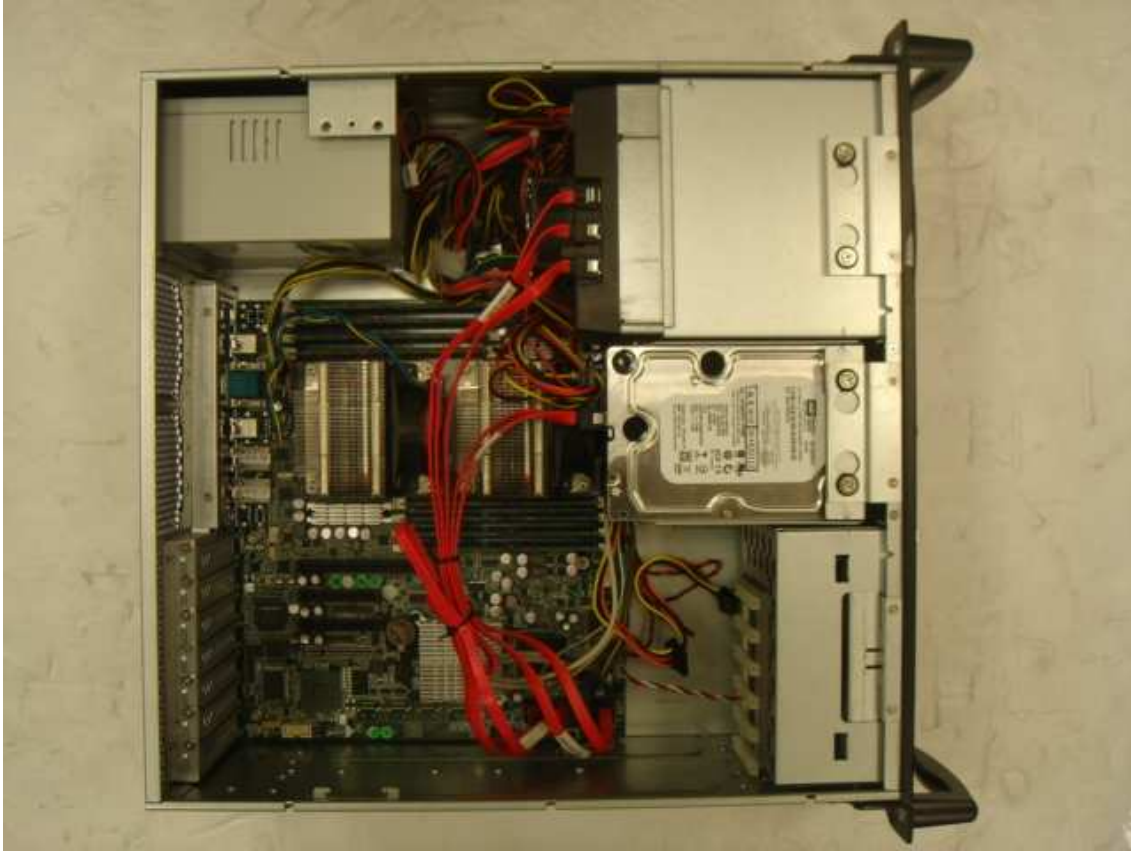
Fig. 3 – System Setup

Component	Manufacturer	Model Number	Q'ty	Specification
Chassis	Chenbro	RM42300	1	Rackmount Server chassis
Main Board	Tyan	S7002	1	Full Function
CPU Type	Intel	Intel®Xeon® X5560	2	2.8GHz Socket 1366
Memory	ATP	AL56M72B8BJH9S	8	2048MB DDR3-1333 ECC REG
Chipset	Intel	ICH10R	1	Full Function
VGA (on board)	ASPEED	AST2050	1	On board
Hard Drive	Western Digital	WD1002FBYS-01A6B0	3	SATA II 1TB
Hard Drive	Western Digital	WD5002ABYS-01B1B0	2	SATA II 500GB
Storage Kits	Chenbro	SK32303	1	3.5" SATS/SAS Hot-swap kit
PSU	Seasonic	SS-500ES	1	500W
System Fan (Front)	AVC	DA12025B12L	1	120x120x25/2500 RPM(PWM)
CPU Cooler	Intel	E28554-001_XA04	2	Active Heat sink

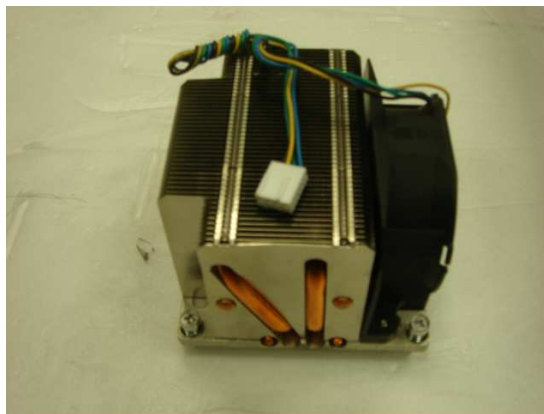
Fig. 4 – Heat Sink

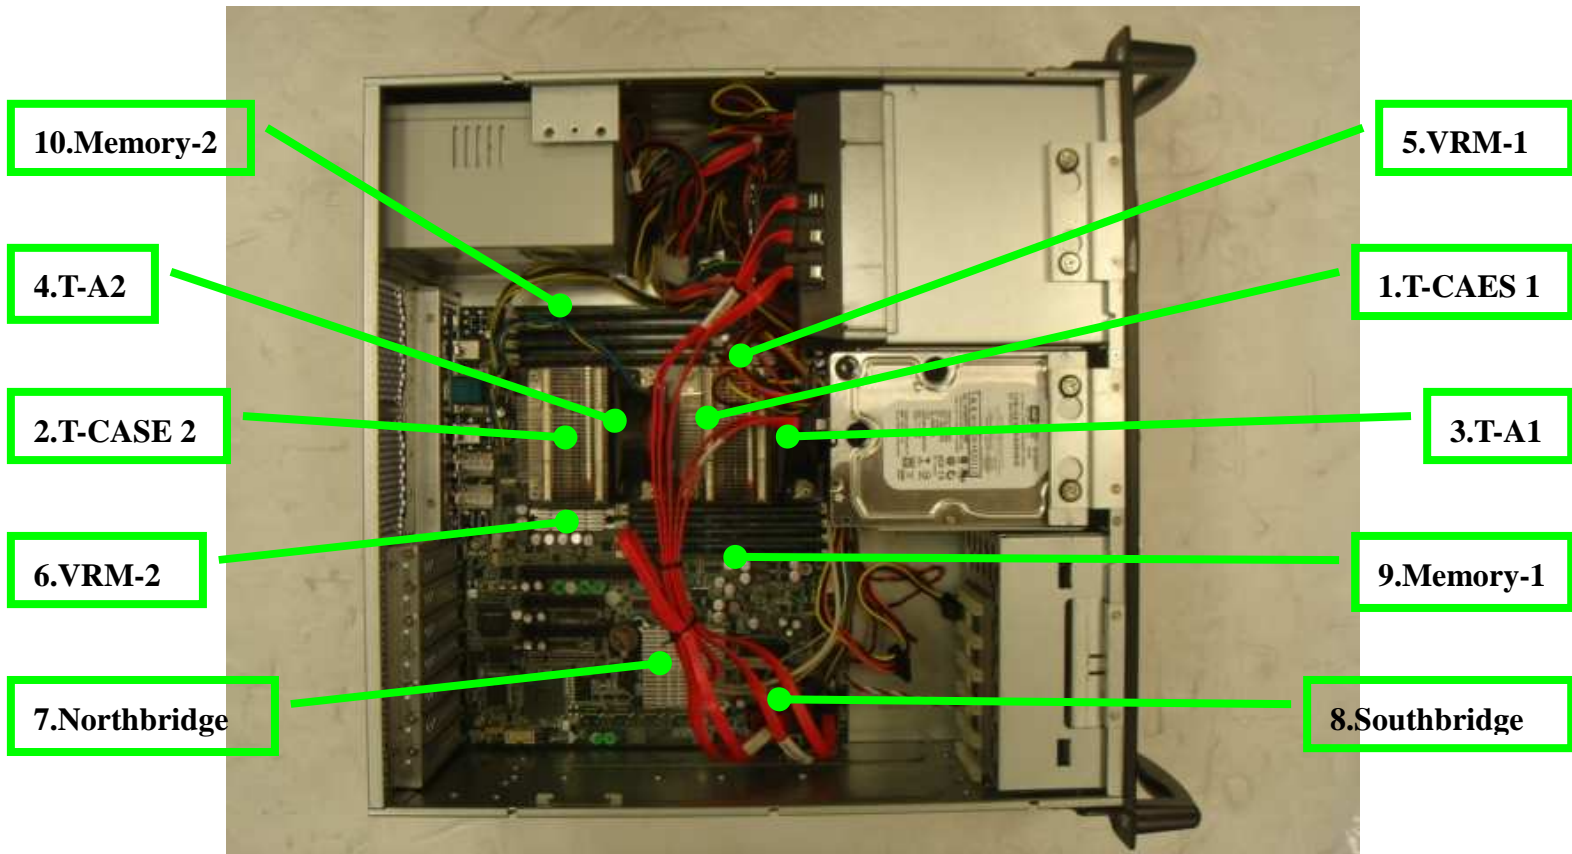
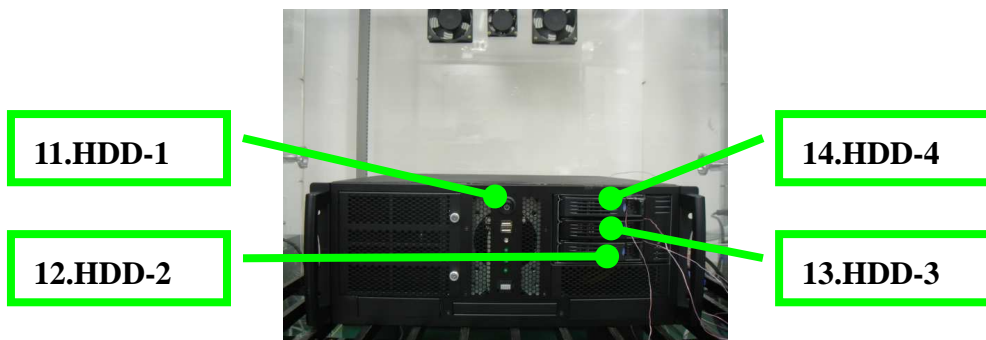
Fig. 5 – Measured Points

Measured Points	Max. Specified Temp Limit (deg C)	Measurements @35 (deg C)	Compensated Data* (deg C)
1.T-CASE 1	74.9	55.1	55.1
2.T-CASE2	74.9	62.3	62.3
3.T-A1	Reference	37.5	37.5
4.T-A2	Reference	43.8	43.8
5.VRM-1	105	58.7	58.7
6.VRM-2	105	78.3	78.3
7.North Bridge	99	77.8	77.8
8.South Bridge	115	65.2	65.2
9.Mmeory-1	Reference	70.5	70.5
10.Mmeory-2	Reference	66.5	66.5
11.HDD-1	55	44.2	44.2
12.HDD-2	55	40.6	40.6
13.HDD-3	55	42.7	42.7
14.HDD-4	55	44.1	44.1
15.T-ROOM	35	35.0	35.0
