## **Thermal Test Report**

Model Name : SR107

Report No.: E64980 Revision 1.0 Date: 2006/04/04

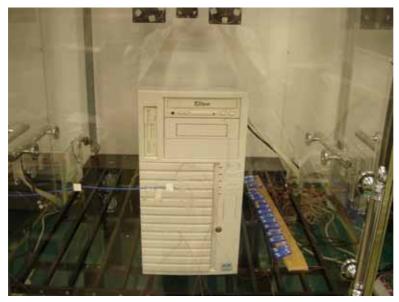
Fig. 1 - Thermal Chamber

The thermal chamber's picture is as following. This thermal chamber can control the Room Ambient Temperature (T-Room) at 35 degree C.
