# Thermal Test Report

Model Name : **RM21706**

Report No.: **E2008121674**  
Revision 1.0  
Date: **2008/12/17**

**CHENBRO MICOM CO., LTD.**

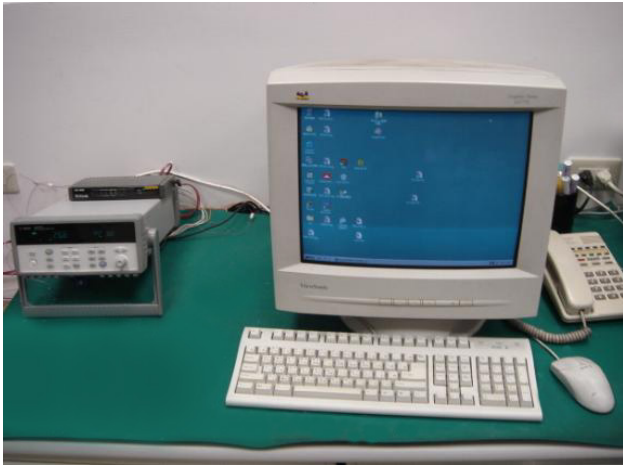
Fig. 2 – Data Acquisition System

The picture of Data Acquisition System is as following. The Data Acquisition System includes one Agilent 34970A, 48 channel temperature recorder and one PC for logging the measured temperature data. The communication interface between recorder and PC is RS-232C.
