Thermal Test Report

Model Name: RM41416

Report No.: E64953 Revision 1.0 Date: 2006/04/28

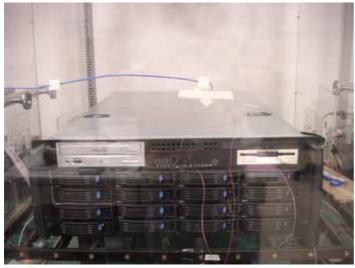
Fig. 1 - Thermal Chamber

The thermal chamber's picture is as following. This thermal chamber can control the Room Ambient Temperature (T-Room) at 35 degree C.

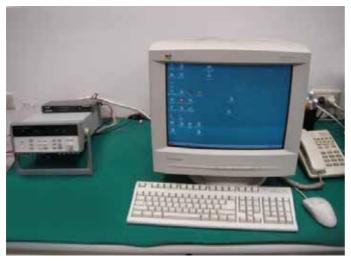
Fig. 2 - Data Acquisition System

The picture of Data Acquisition System is as following. The Data Acquisition System includes one Agilent 34970A, 48 channel temperature recorder and one PC for logging the measured temperature data. The communication interface between recorder and PC is RS-232C.
